Figure E-10 Statutory Checklist

STATUTORY CHECKLIST [§58.35(a) activities]

Project Name and Identification No. 89 Cooper Street, Milford, Connecticut

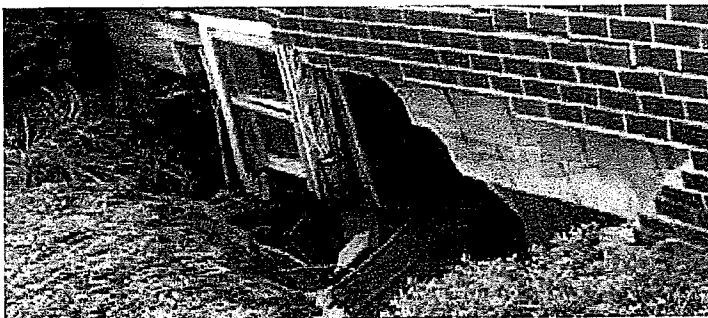
Rapidly rising floodwater can put extreme pressure on the foundation walls causing improperly vented structures to buckle and collapse. SMART VENTS® quickly and efficiently equalize the pressure and minimize damage.

How it works:

Flood Protection: The SMART VENT® door is latched closed until flood water enters. Entering flood water lifts the patented internal floats which unlatches and rotates the door open. This allows the flood water to automatically enter and exit through the frame opening, relieving the pressure from your foundation walls.

Ventilation: A bimetal coil (like a thermostat, no electricity is needed) automatically opens and closes the ventilation louvers as temperature changes. They will be closed when it is freezing outside and open when it is warm outside to provide natural ventilation.

Important note: SMART VENT® does not rely on the louvers to let floodwater in and out. Regardless of the louvers' position, opened or closed, when floodwater flows into the door, the internal floats release the door to rotate open to relieve the hydrostatic pressure. The louvers and pest screen are rotated out of the path of the floodwater. The temperature-controlled louvers are for ventilation purposes only.
